# Manhole Inspection Summary

Manhole # S39S\_\_019MH

**Inspection** ☐ Is Incomplete Rating: **3) Fair**

Insp Date: **3/13/08 1:33 PM**

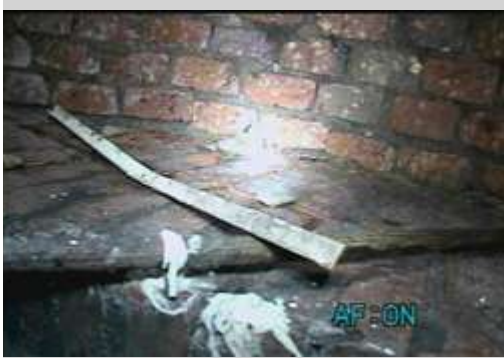
misc

bench debris

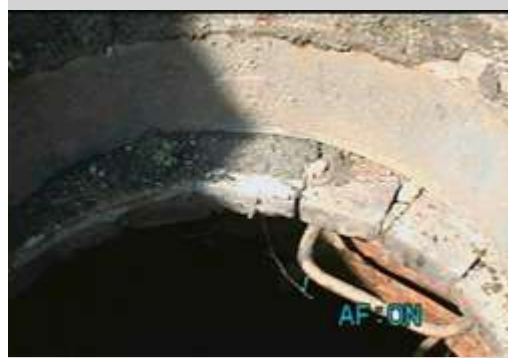
Defect 2

**Frame** Offset: **5** (in.) Condition: ☒ Sound ☐ Cracked ☐ Leaks

Condition: ☐ Sound ☐ Cracked ☐ Root Intrusion ☒ **Loose Brick** ☐ Deteriorated

frame offset, corbel loose bricks

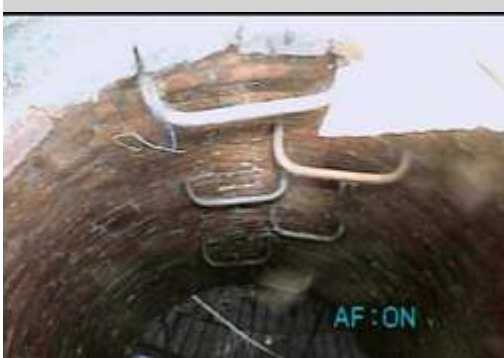
Defect 1

**Steps** Count: **6** Missing: **0** ☒ **Corroded**

corroded steps

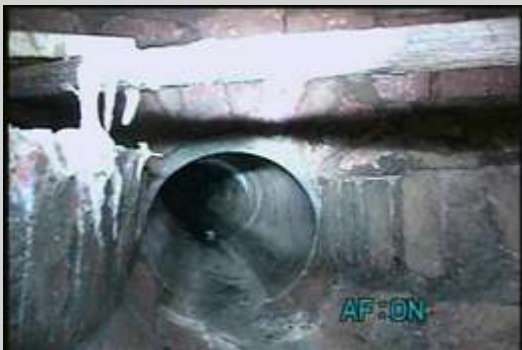
12 O'Clock Outflow

8 in. Circular Gravity Sewer  
Pipe Out @ 12 O'Clock

Pipe Material: Clay ☐ Pipe Lined

Invert Depth: 9.80 (ft.) Flow Characteristics: Slow

Deposits: ☒ None ☐ Mud ☐ Sludge ☐ Debris ☐ Grease

Infiltration: None Pipe Seal Cond: Unknown

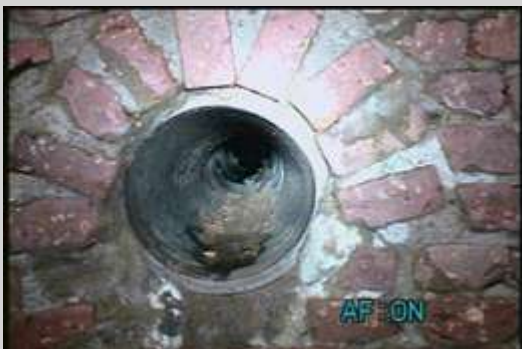
3 O'Clock Inflow

8 in. Circular Gravity Sewer  
Pipe In @ 3 O'Clock

Pipe Material: Clay ☐ Pipe Lined

Invert Depth: 6.10 (ft.) Flow Characteristics: Slow

Deposits: ☒ None ☐ Mud ☐ Sludge ☐ Debris ☐ Grease

Infiltration: None Pipe Seal Cond: Unknown

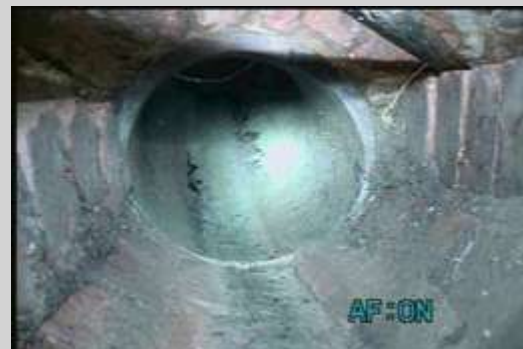
Drop In @ 3 O'Clock

Drop: Inside Direct

Inv Depth: 9.50 (ft.)

Drop Condition: Open

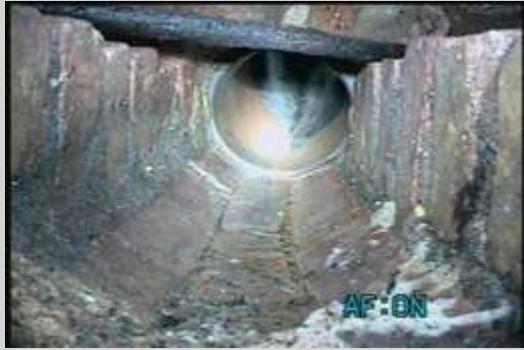
7 O'Clock Inflow

8 in. Circular Gravity Sewer  
Pipe In @ 7 O'Clock

Pipe Material: **Clay** ☐ Pipe Lined

Invert Depth: **9.40** (ft.) Flow Characteristics: **Slow**

Deposits: ☒ None ☐ Mud ☐ Sludge ☐ Debris ☐ Grease

Infiltration: **None**

Connects To: **House connection / Service line**
